BUFFALO OUTER HARBOR ACCESS & ACTIVATION CIVIC IMPROVEMENTS

# **EXISTING CONDITIONS ASSESSMENT EXECUTIVE SUMMARY**

Erie Canal Harbor Development Corporation

August 2017

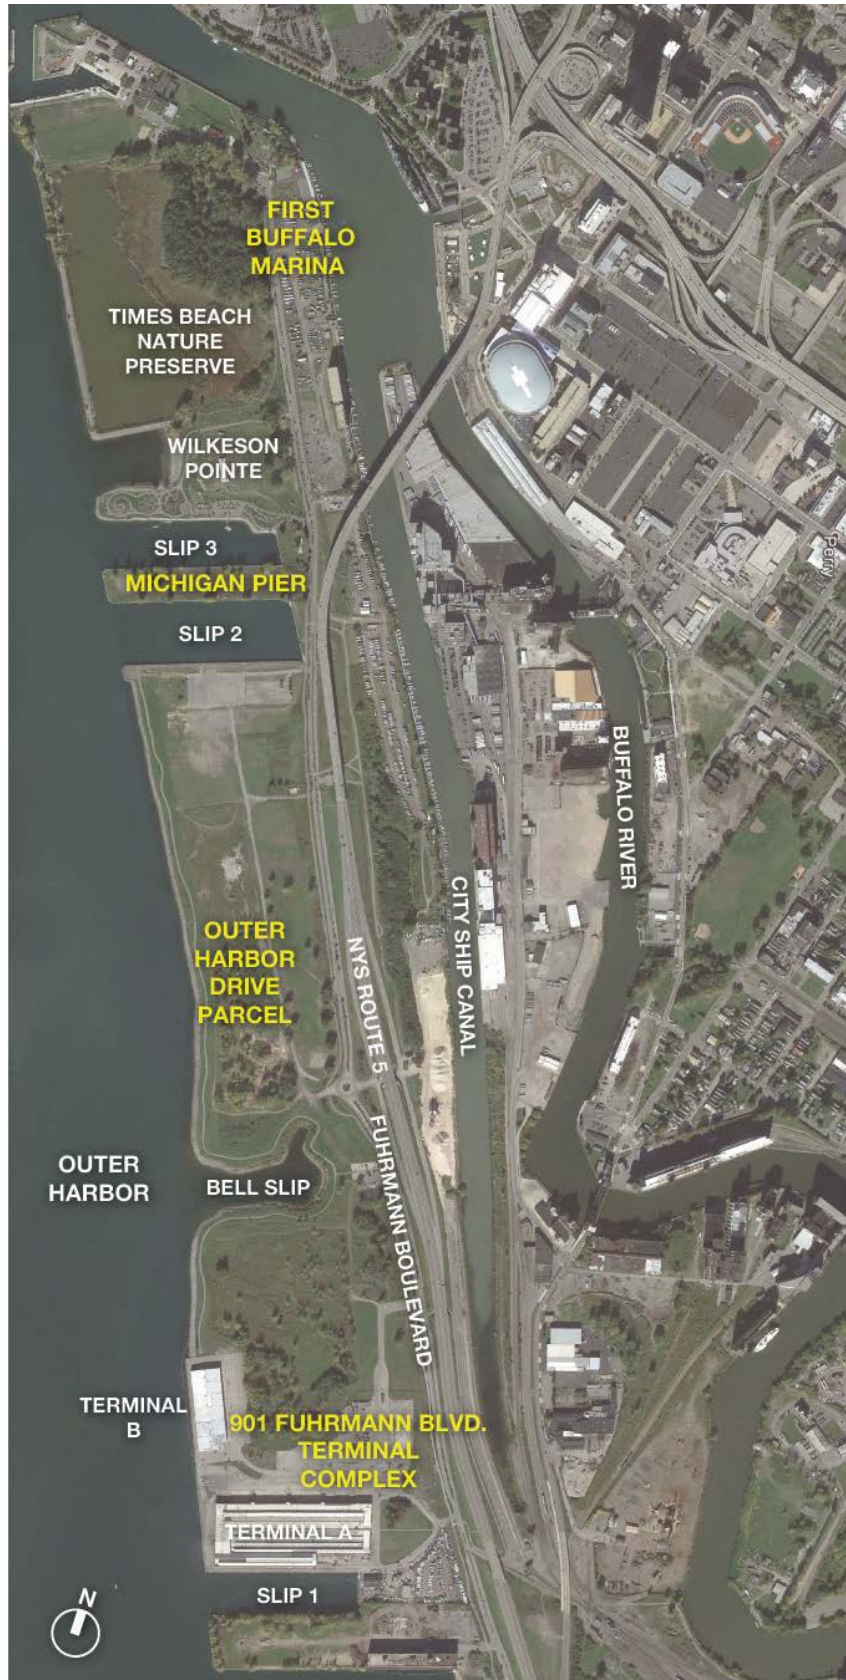
Figure 1: Overall Project Area

The first task was to conduct a property conditions assessment of existing facilities. The sites that were investigated are: the First Buffalo Marina, Michigan Pier, the Outer Harbor parcel, and 901 Fuhrmann Boulevard/Terminal Complex. Refer to Figure 1: Overall Project Area for locations of each of the sites.

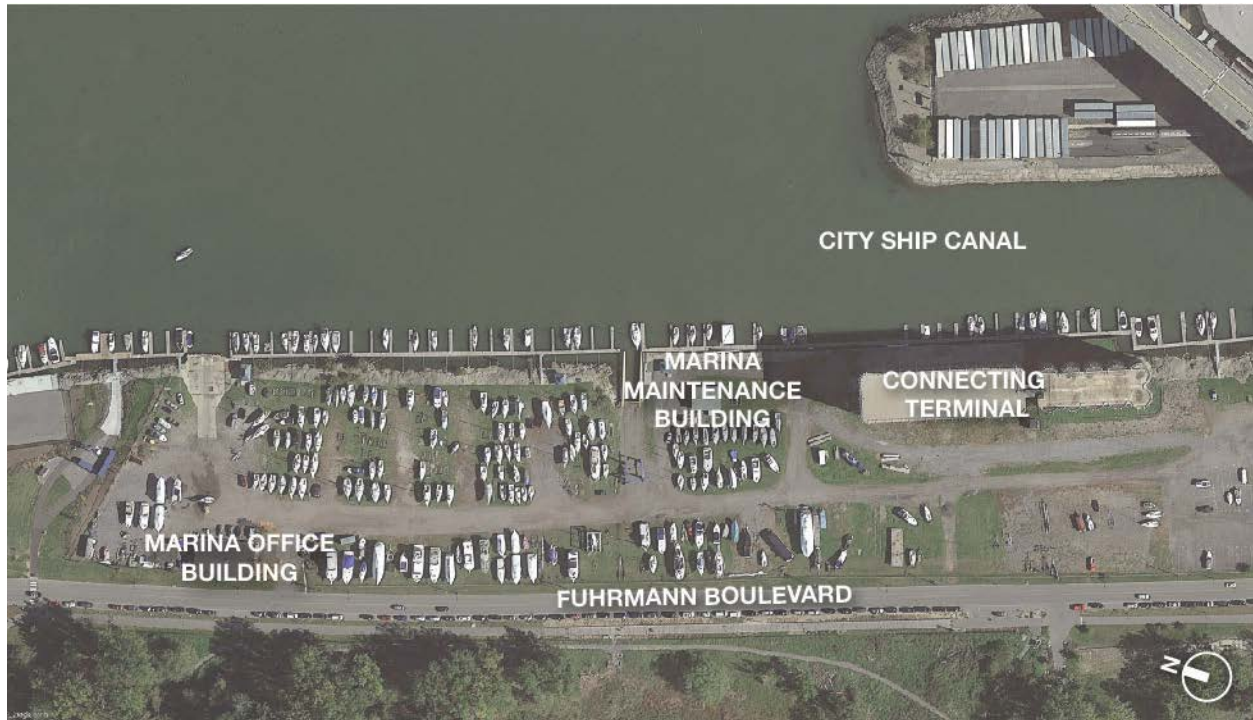
Figure 2: First Buffalo Marina
